Inspection and diagnosis of corrosion in reinforced concrete buildings of the cultural heritage

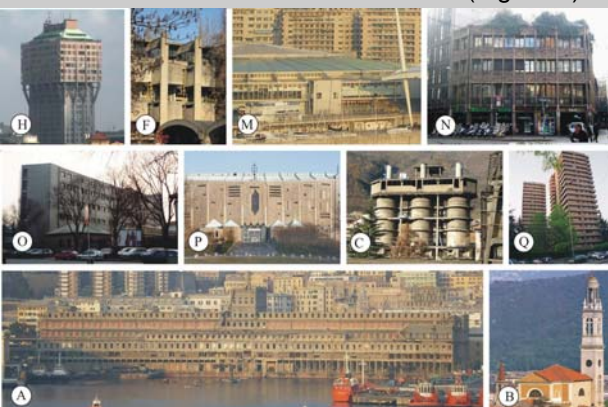
Figure 1 - Some examples of the inspected structures (labels refer to the designation of the buildings according to Table 1).

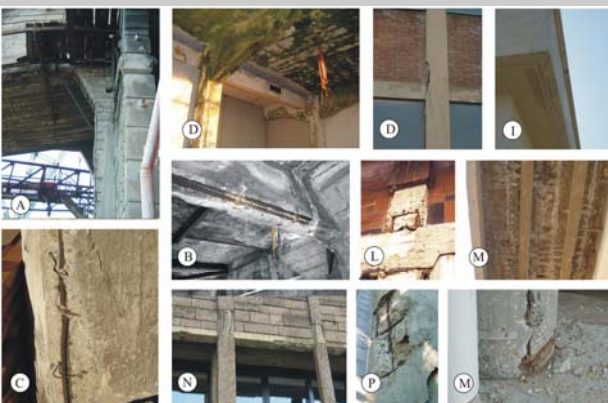
Since the beginning of the 20th century, in Italy as in many other countries, reinforced concrete became one of the most popular construction materials and it was used for buildings, monuments, infrastructures and industrial structures. This work describes a study on several structures, that although of recent formation, have now been included in the cultural heritage, because of their architectural or social relevance (Figure 1, Table 1). As a consequence of the typical urban or rural exposure conditions of these buildings, they often suffer damage due to carbonation-induced corrosion of reinforcement, often associated with the presence of low values of concrete cover thickness (Figure 2).

Figure 2 - Effects of corrosion (labels refer to the designation of the building according to Table 1).
